Short Note

OXYGEN CAUSES CORROSION FAILURE OF HEAT EXCHANGER

M.L. Mehta*, T.S. El-Mendelssi,** and A.M. El-Houde**

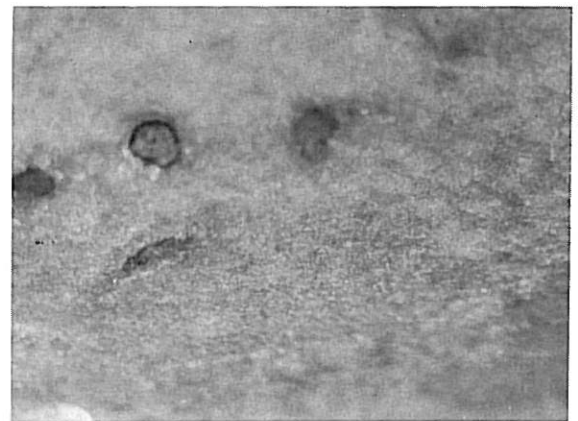
As received tube sample showed pitting to varying depth on its external surface. Fragile scale, black at some places and brown at others, is evident.

Cluster of pits were visible in some places, and their growth had led to coalescence resulting in a wider pits causing leaks. Macroscopic examination of transverse section through a pit revealed a hemispherical morphology. The internal tube side exposed to the heating oil did not show any corrosion attack.

Deep pits were found underneath the scale layer and filled with black scale indicative of bacterial growth. The top layer of the scale was brownish and soluble in HCl acid confirming the formation of iron oxides.

FIG. 2. Pitting corrosion of tube section.

were filled with the corrosion products. (Fig. 2 shows pitting corrosion of tube section). Highly elongated grain structure is representative of high degree of deformation, as is the case shown in (Fig. 3a and Fig. 3b).

Underscale oxygen attack of the external tube surface was mainly of the pitting type. The scale chemistry and the presence of soluble oxygen in the water confirm the oxygen attack. The severity of the attack is promoted with the setup of the oxygen concentration cells on the scale layer. The presence of layered scale has also activated sulfide reducing bacteria growth. The chemical treatment of the raw water is definitely ineffective and it is recommended that the oxygen ingress be eliminated at the source of entry prior to any inhibition program.

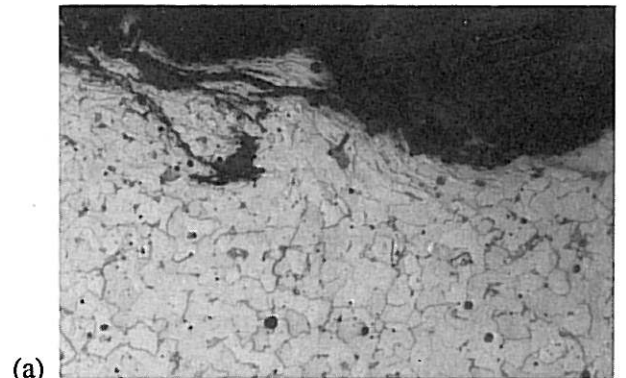
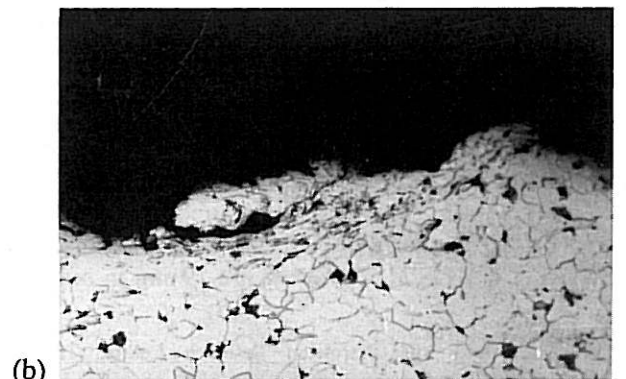
Upon Microscopic examination it was clear that the grain structure in the tube steel had suffered elongation due to plastic deformation. Such deformation could be attributed to either the manufacturing process of the tubes, or to the localized internal stresses due to the volume expansion when the pits

FIG. 3a,b. Deformed grain structure of tube section.
