Short Note

STUDY OF CORROSION DAMAGE TO CU/NI CHLORINATOR LINE BY SEA WATER

M.L. Mehta* and A.T. Hassan*

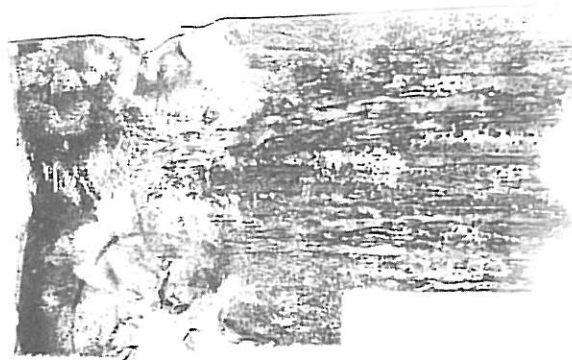
Failed section of the chlorinated tube in the as-received condition is shown in Fig. 1. It had been cut

FIG. 1. As received failed section of chlorinator line showing extensive pitting, channels and perforation.

longitudinally and then flattened. The internal surface shows extensive pitting corrosion and formation of channels/grooves. Pits are shallow and degree of pitting is different in different regions. Colour of the surface film formed on the alloy substrate is mostly dark brown in colour and in some regions such as original substrate film is dark brown, spotty and not very adherent. The area surrounding the perforation is partly covered with the film and has finer pits but no channels (Fig. 1). Thickness was measured at different locations and are marked in Fig. 1. In the region surrounding the leak thickness had been reduced to 0.5 mm compared with original thickness of 1.5 mm indicating considerable corrosion in this localized area.

It was scrapped from the substrate of the failed section shown in Fig. 1. Since the film was thin and only a very small quantity of the material could be collected, the diffraction pattern of this material was not of very high quality. Analysis of the pattern revealed that scrapped material constituting corrosion product layer was identified to consist of cuprous sulphide.

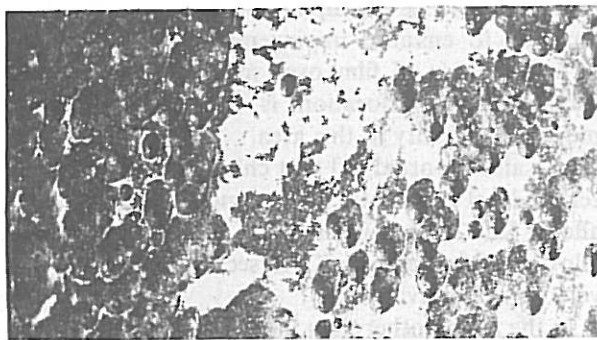
The morphology of localized attack tend towards horse-shoe morphology (Fig. 2 a,b). Initially pits are formed as seen in Fig. 3a and then these pits grow to emerge into one another leading to the observed morphology. These horse-shoe attack propagate further leading to channel formation as illustrated in Fig. 3b. Within the horse-shoes cracked corrosion product layer was detected as in Fig. 4. In perforated/leaked region shallow horse shoe morphology of attack is observed (Fig. 5), but no channels/grooves were formed.

FIG. 2(a). Corrosion attack tending towards horse-shoe morphology. $\times 64$.

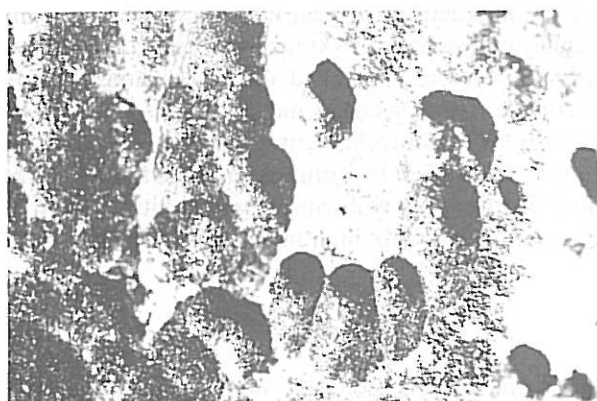
FIG. 2(b). Corrosion attack tending towards horse-shoe morphology. $\times 16$.

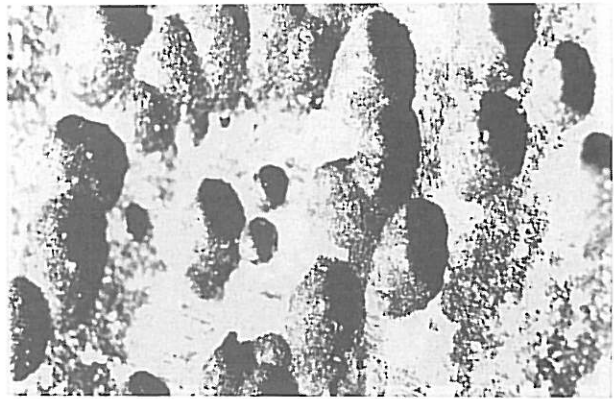
FIG. 3(a). Showing early stages of pit formations in original substrate and growth of pits into horse-shoe morphology and channel formation.

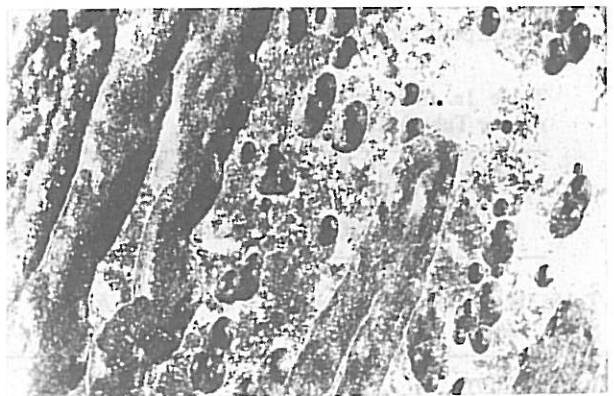
FIG. 3(b). Side-way growth of channels leading to wider channel. $\times 16$.

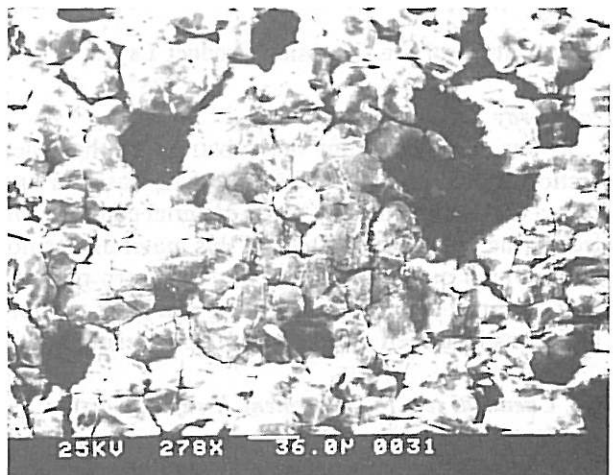
FIG. 4. Scanning electron micrograph showing cracked corrosion product within a horse-shoe.

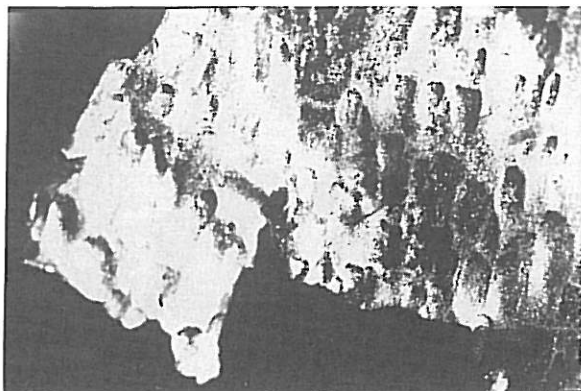
FIG. 5. Horse-shoe morphology of corrosion attack at the perforation site. $\times 6.4$.

Flow velocity in the chlorinator line is 0.45 m/sec (1.5 ft/sec) and is much lower than minimum flow velocity required to result in erosion-corrosion. Perforation in the chlorinator line has been caused by localized impingement attack. It is difficult to establish the cause of the localized enhancement of flow required.

One of the main causes of localized impingement attack in a straight tube as in the present case is some sort of partial internal lodgement causing local turbulence. Presence of sulphide in sea water has been reported to enhance impingement attack. The observed absence of film over most of the area surrounding the perforation is indicative of higher prevailing velocity in this area.
