THE ATMOSPHERIC CORROSION OF AUSTENITIC STAINLESS STEEL PNEUMATIC TUBING SYSTEM IN AN OFFSHORE ENVIRONMENT

M.L. Mehta* and K. Abosowa*

Leaks were reported in the pneumatic stainless steel tubing after about two years in service. The surface of the tubing was exposed to off-shore environment. The tubing system is used for instrumentation purpose. It is reported that the tubing material as per specification is 316 austenitic stainless steel.

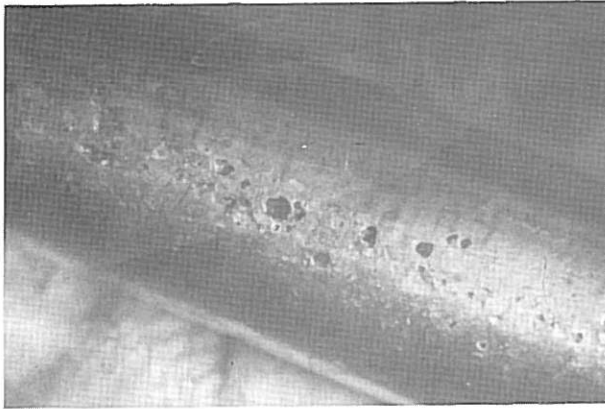
Localized attack did not take place over the whole tube surface but was confined to a narrow band in the longitudinal direction as illustrated in Figs. 1, 2. Such morphology results from crevice corrosion. Scattered pits as in Fig. 3 were also seen. Figure 4 shows a ring around a cluster of pits indicating the existence of a deposit over these pit sites, which had come off. Figure 4a reveals the growth of adjacent

FIG. 1. A band of pits resulting from crevice corrosion $\times 6$.

Localisation of crevice attack to one side of the tubes suggests that the tubes remained in contact with other tubes/holding channels. This contact areas remain shielded from the supply of oxygen creating differential aeration corrosion cells. Salt deposited on the tube surface from marine atmosphere accelerates corrosion activity in corrosion cell [1], causing local break-down of passive film leading to crevice and pitting corrosion.

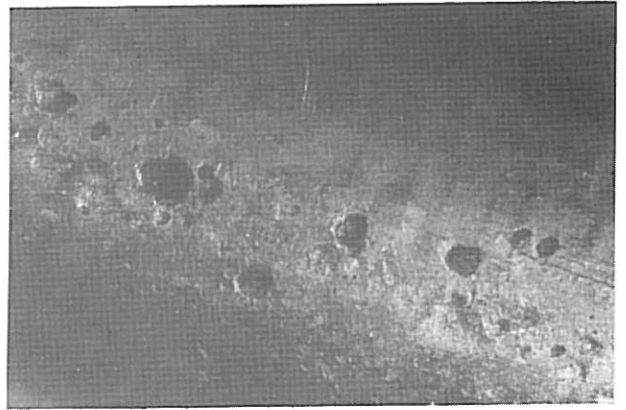
FIG. 2. Another area showing crevice corrosion $\times 12$.

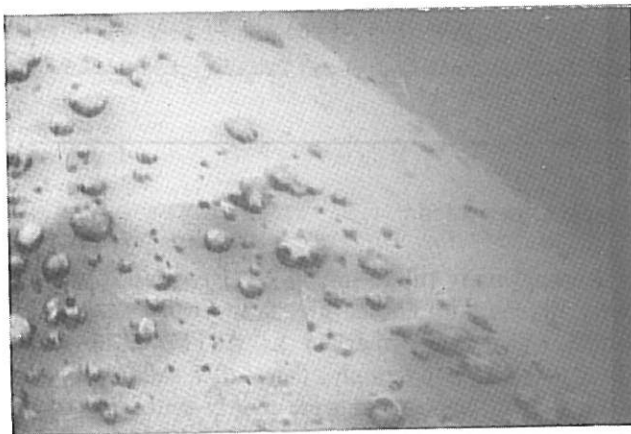
FIG. 3. Scattered pits and particles deposited on tube surface $\times 64$.

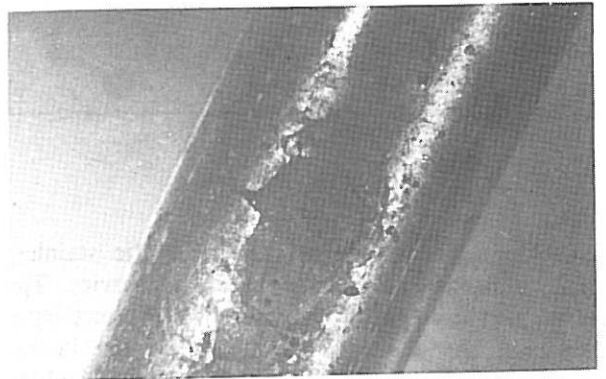
FIG. 4. A ring around a cluster of pits $\times 6$.

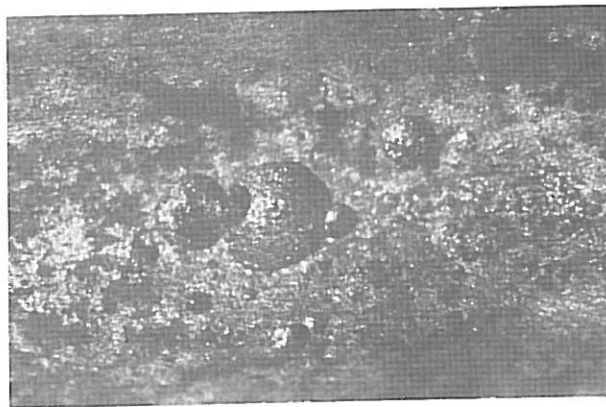
FIG. 4a. Growth of adjacent pits leading to a large pit $\times 12$.

pits till they emerged into one another leading to large pits. Figure 5 illustrates pits under the particle deposits on the tube surface.

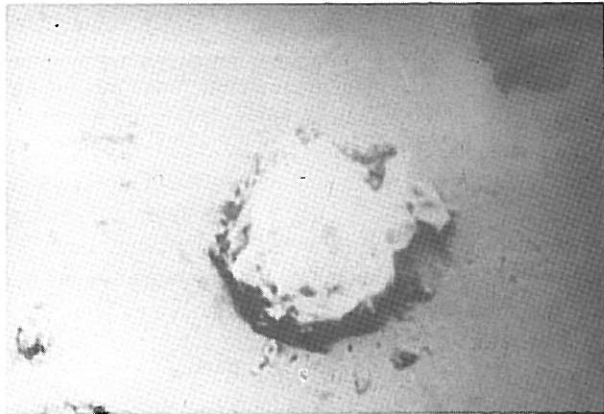
FIG. 5. A pit under the particle deposit $\times 124$.

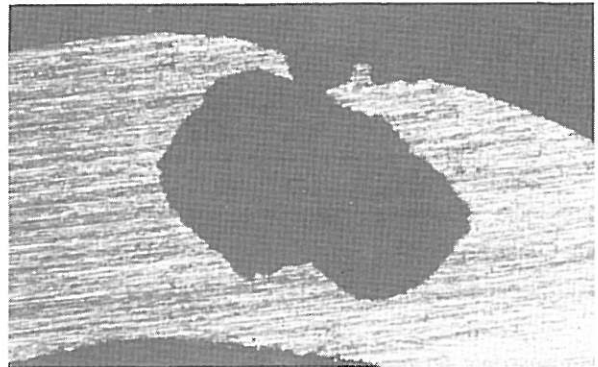
This was carried out in the transverse section of the pitted region of the tube. Figure 6 shows the undercut appearance of a pit indicating typical

chloride attack. The pit has penetrated about 4/5 of the wall thickness. Figure 7 illustrates another morphology (open pit). Figure 8 shows a pit in the cross-section of the tube which penetrated at an angle to the tube surface. Microstructure was examined in the transverse section of the tube. Figure 9 shows that the tube was not seamless, but it was fabricated through fusion welding and the structure of weld was

FIG. 6. Under-cut pit typical of chloride attack $\times 65$.

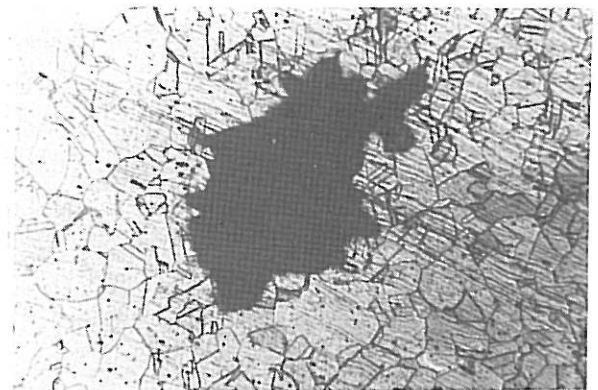
FIG. 8. A pit in the tube cross section $\times 260$.

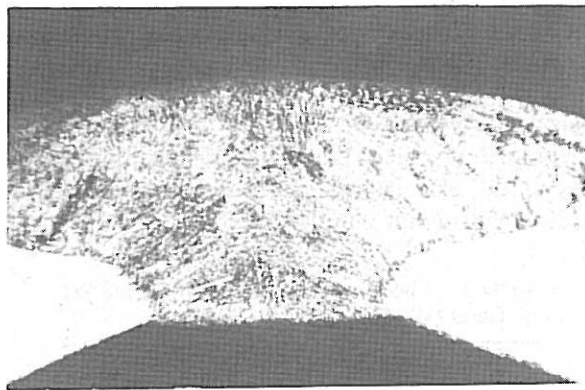
FIG. 9. Fusion weld having dendrite structure $\times 65$.

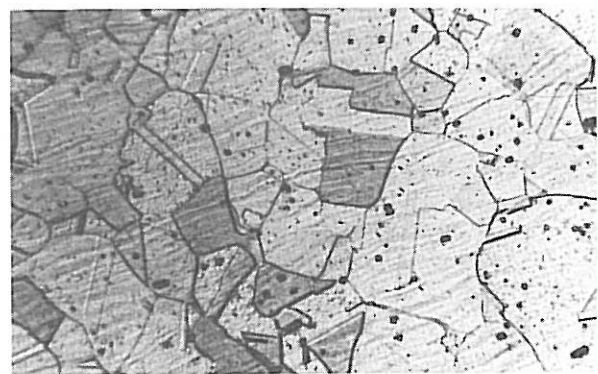
FIG. 10. Microstructure showing grain structure, annealing twins, second phase precipitates and deformation markings $\times 520$.

dendritic. The structure of the base metal as seen in Fig. 10 consists of equiaxed grains, annealing twins, second phase particles and tube has been subjected to slight cold deformation as evident from the presence of deformation markings due to slip.

of second phase particles as seen in the micro-structure of first set of tubing increases pit initiation [2].

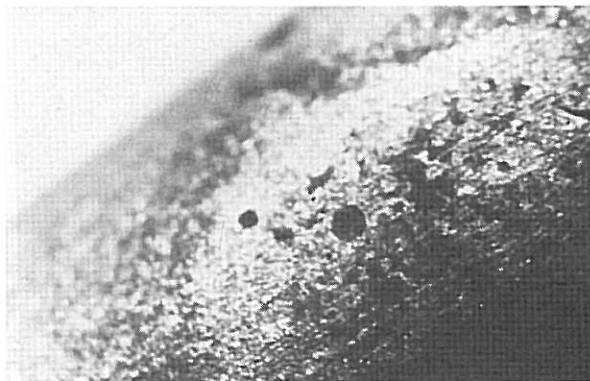
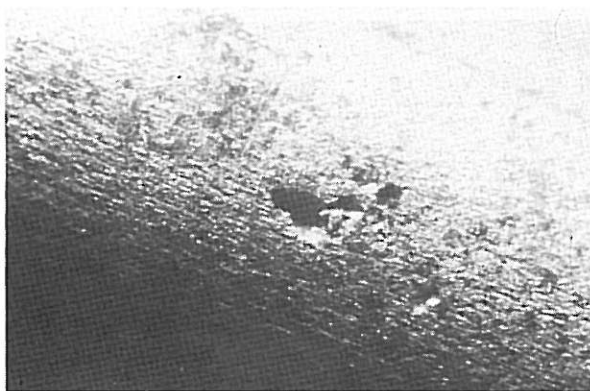
Mild pitting was observed on tubing surface as illustrated in Fig. (11a,b) and had random distribution.

FIG. 11a,b. Show pits in the tube surface of second set of tubes $\times 6$.

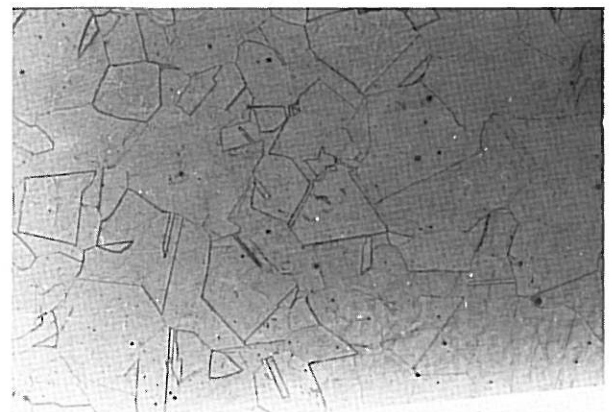
Microstructure consists of equiaxed grain structure showing twinning and presence of second phase particles as seen in Fig. 13; quantity being much less than that detected in the first set of tubes.

FIG. 13. Microstructure showing less quantity of second phase precipitates $\times 400$.
