H₂S INDUCED LOCALIZED CORROSION OF AUSTENITIC STAINLESS STEEL BELLOW: A CASE STUDY

M.L. Mehta* and A.T. Hassan*

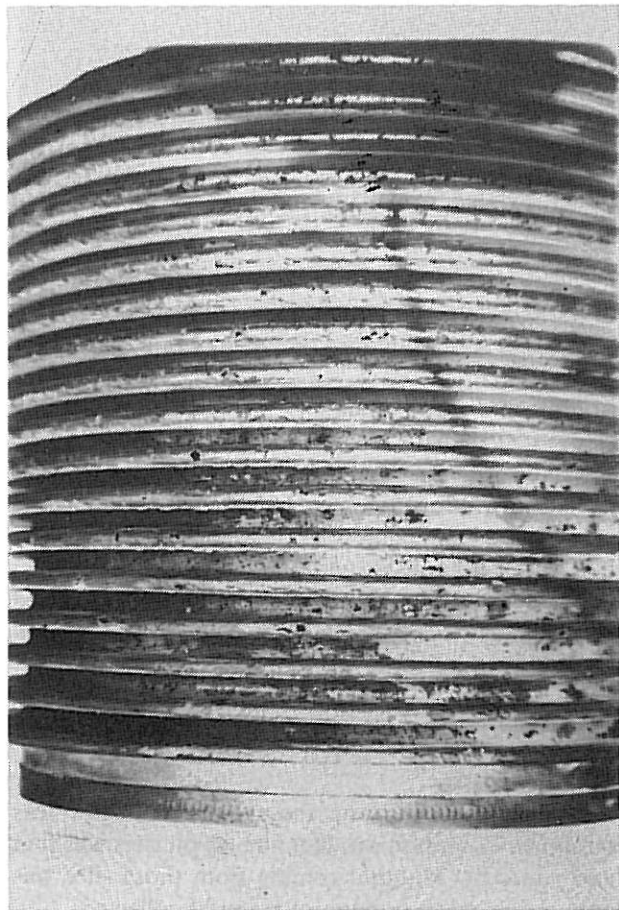
Since flange of the relief valve is connected to the flare line, external surface of bellow is exposed to the gases of the flare line. Operational pressure within the bellow is maintained in the range from 0.02 to 0.06 kg/cm² above atm pressure and temperature about 38°C. Bellow was observed to suffer from localized corrosion, causing perforations (Fig. 1) resulting in gas leaks making it difficult to maintain desired pressure within the bellow for operation of the valve.

FIG. 1. Localized corrosion causing perforation.

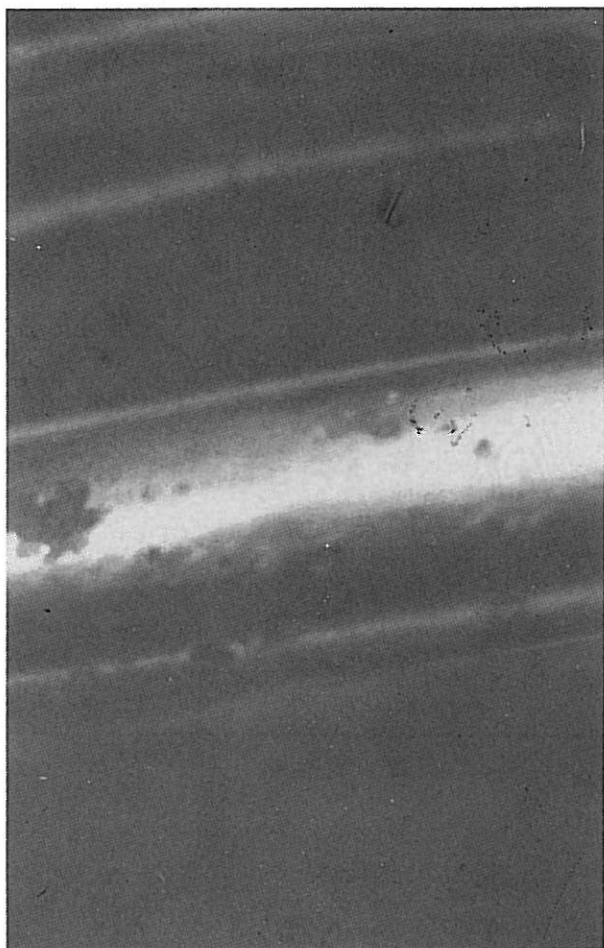
Extensive pitting were observed both on internal and external surfaces of the bellow. Some of the pits have propagated through wall thickness (0.3 mm) of the bellow. Fig. 2 shows pitting on the external surface of the bellow in their different stages of developments. Some pits had initiated revealing that pitting can start from outer surface and environment surrounding the external surface of the bellow is also corrosive enough to cause pit initiation and their propagation. Deposit

FIG. 2. Pitting on external surface of the bellow showing different stages of their growth X6.

of particles on surfaces of bellow was also observed. Sites of pit formation had presence of thin black film.

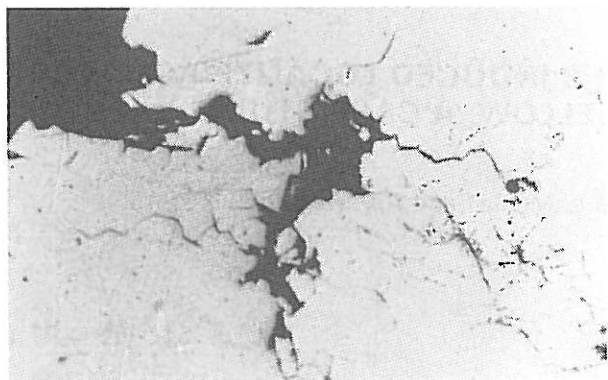
Samples having different degrees of pitting were cut from bellow. Morphology of localized corrosion in the form of intercrystalline cracking, intercrystalline corrosion as well as pitting corrosion were detected as seen in Fig. 3. Figs. (4a, 4b) show early stages of localized attack which started from grain boundaries and progressed into grains to form pits.

FIG. 3. Intercrystalline cracking and pitting (unetched) X500.

The observation that bellow has also suffered from intercrystalline cracking is difficult to explain as they could be caused by either corrosion fatigue or stress corrosion cracking. Since bellow is subject to pressure variation due to its nature of operation, corrosion fatigue appears to be more probable. It is also observed that initially intergranular attack occurs as illustrated in Fig. 4 and this spreads leading to formation of pits.

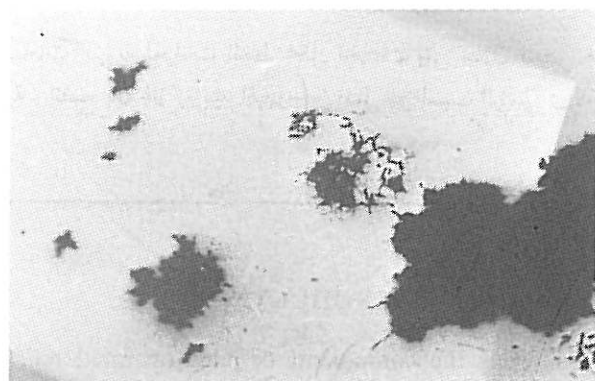
FIG. 4(a). Showing pits in their different stages X125.

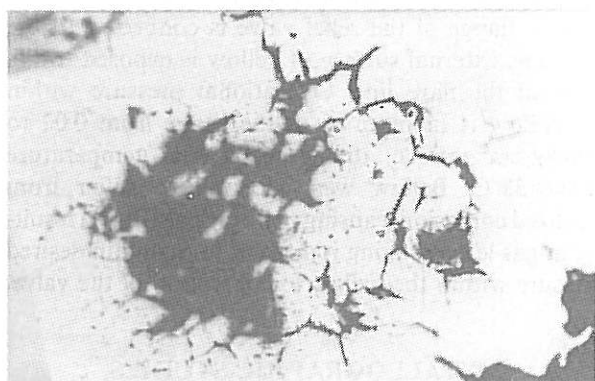
FIG. 4(b). Encircled area in Fig. 4a showing intergranular attack leading to formation of pits X500.

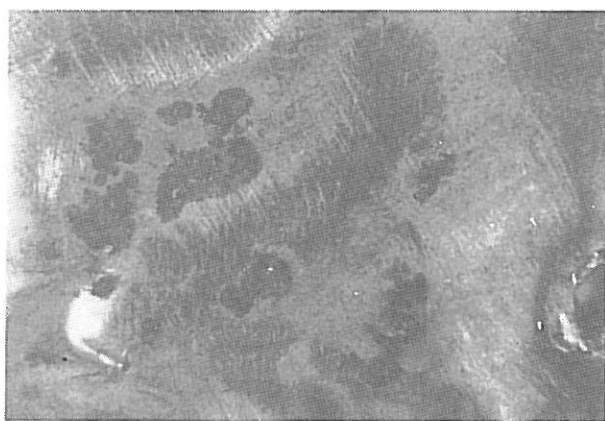
In order to ascertain that wet H₂S gas can cause pitting corrosion of bellow material, small samples from bellow after cleaning were exposed to wet H₂S gas as described here. Distilled water, (75 ml), was taken in 250 ml Duran glass bottle with a tight cap. It was first purged with high purity Nitrogen gas for 10 minutes and then H₂S gas for 15 minutes. One sample was fully immersed in the solution and the other one was exposed above the solution level. The bottle was sealed to prevent entry of air and to generate wet H₂S gas environment above solution level. Temperature was maintained at 38°C. After two days small black spots appeared on the sample above solution level which grew with time. Solution was observed to turn milky. Samples were removed from the bottle after seven days and solution was analysed to contain 0.8 ppm H₂S. Fully immersed sample did not show any corrosion. Fig. 5 shows localized corrosion on the

FIG. 5. Pitting caused by exposure to wet H₂S above solution level X6.

sample exposed to wet H₂S gas above water level. Solution had turned milky indicating that there was presence of residual oxygen in the solution reacting with H₂S to form sulphur.
