FRACTOGRAPHY EXHIBITED BY HYDROGEN EMBRITTLED AUSTENITIC STAINLESS STEELS

F.O. El-Shawesh*

ABSTRACT

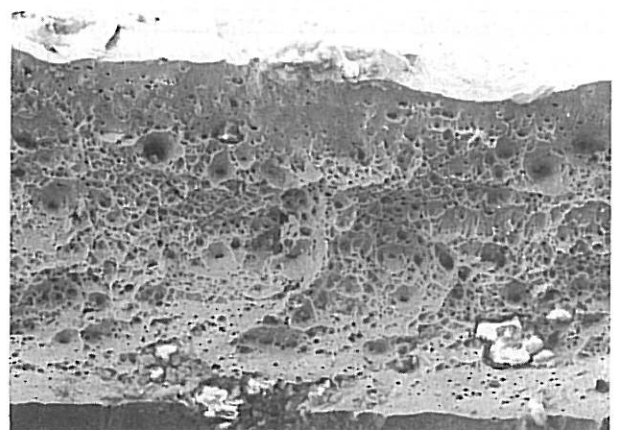
Three features were observed on the fracture surfaces of the tested specimens: dimples, cleavage and intergranular. Dimpled rupture was the only fracture mode observed on the specimens tested in air as shown in Fig. 2. The other two fracture modes were found only in specimens that were embrittled as a result of absorbed hydrogen.

FIG. 2. S.E.M. fractography shows typical ductile fracture of stainless steel specimen fractured in air.

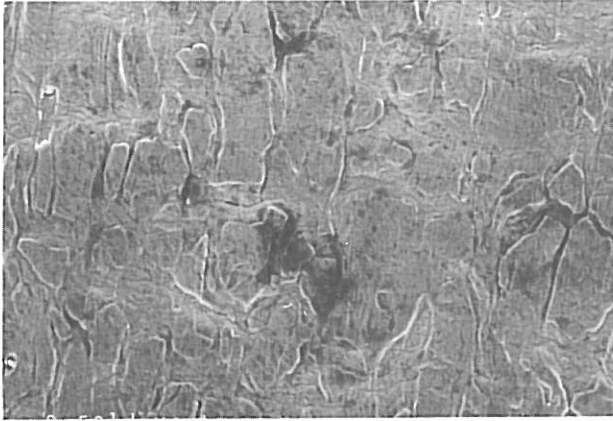
Surface cracks on the surface of hydrogen embrittled less stable 304 austenitic stainless steel specimens in annealed, sensitized and cold worked condition and more stable 310 austenitic stainless steel specimens in annealed condition are shown respectively in Fig. 10–13. Both intergranular and transgranular cracks were observed on the surfaces of these tested specimens. Some of transgranular cracks were observed to propagate along or parallel to the slip bands as shown in Fig. 10 for 304 austenitic stainless steel specimens in annealed condition. Cold worked specimens exhibited less surface cracks compared to the annealed specimens as shown in Fig. 11. Sensitized specimens showed more transgranular cracks

FIG. 11. S.E.M. micrograph of an 12% cold worked 304 austenitic stainless and specimen strained in solution at a crosshead of 9.8 nm/s. Micrograph shows very little surface cracks.

Less cracking was observed in 12% cold worked 304 austenitic stainless steel compare to non cold worked specimens as can be seen by comparing Fig. 10 with Fig. 11. This can be attributed to the pre-existing of α martensite in the surface of cold worked specimens which may provide a rapid path for hydrogen to diffuse away from the specimen surface [25]. Thus preventing the build up of the critical concentration of hydrogen thought to be necessary for the formation of the expanded phases (γ^* and ϵ^*) [25, 26].
