PRJ, Vol. 7 (January 1995); P. 107–109, 4 FIGS, 2 TABLES.

Short Note

OXYGEN CAUSES CORROSION FAILURE OF HEAT EXCHANGER

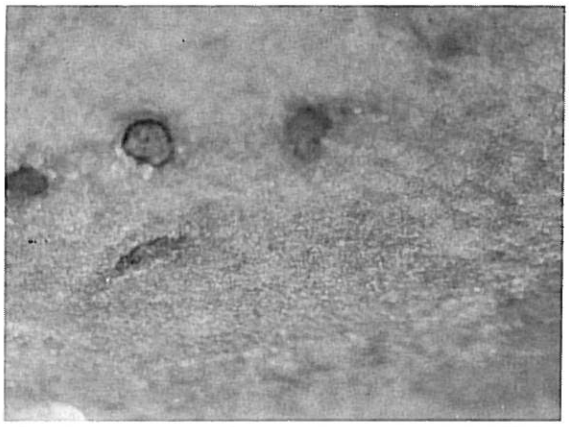
As received tube sample showed pitting to varying depth on its external surface. Fragile scale, black at some places and brown at others, is evident.

Cluster of pits were visible in some places, and their growth had led to coalescene resulting in a wider pits causing leaks. Macroscopic examination of transverse section through a pit revealed a hemispherical morphology. The internal tube side exposed to the heating oil did not show any corrosion attack.

Deep pits were found underneath the scale layer and filled with black scale indicative of bacterial growth. The top layer of the scale was brownish and soluble in HC1 acid confirming the formation of iron oxides.

were filled with the corrosion products. (Fig. 2 shows pitting corrosion of tube section). Highly elongated grain structure is representative of high degree of deformation, as is the case shown in (Fig. 3a and Fig. 3b).

FIG. 2. Pitting corrosion of tube section.

Underscale oxygen attack of the external tube surface was mainly of the pitting type. The scale chemistry and the presence of soluble oxygen in the water confirm the oxygen attack. The severity of the attack is promoted with the setup of the oxygen concentration cells on the scale layer. The presence of layered scale has also activated sulfide reducing bacteria growth. The chemical treatment of the raw water is definitely ineffective and it is recommended that the oxygen ingress be eliminated at the source of entry prior to any inhibition program.

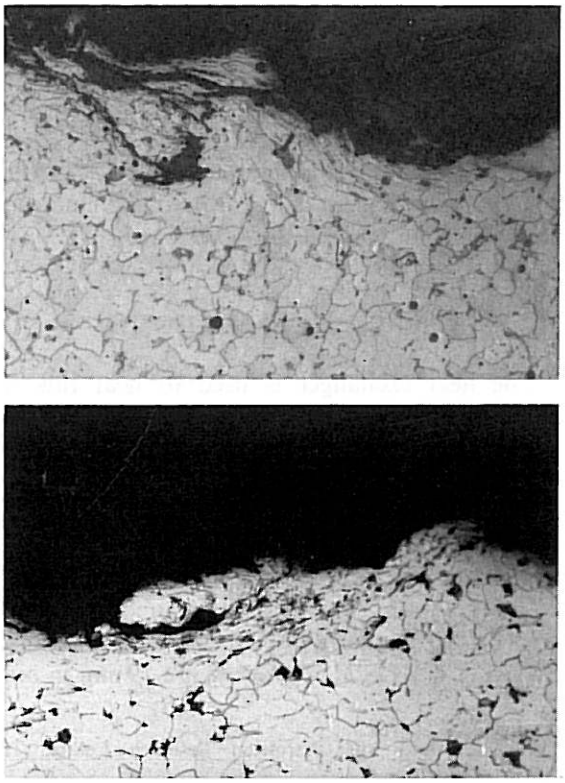
Upon Microscopic examination it was clear that the grain structure in the tube steel had suffered elongation due to plastic deformation. Such deformation could be attributed to either the manufacturing process of the tubes, or to the localized internal stresses due to the volume expansion when the pits

FIG. 3a,b. Deformed grain structure of tube section.
