PRJ, Vol. 5 (January 1993); P16–21, 5 FIGS, 2 TABLES.

CORROSION CONTROL IN DEFA WATERFLOOD SYSTEM

M.A. Elarabi*

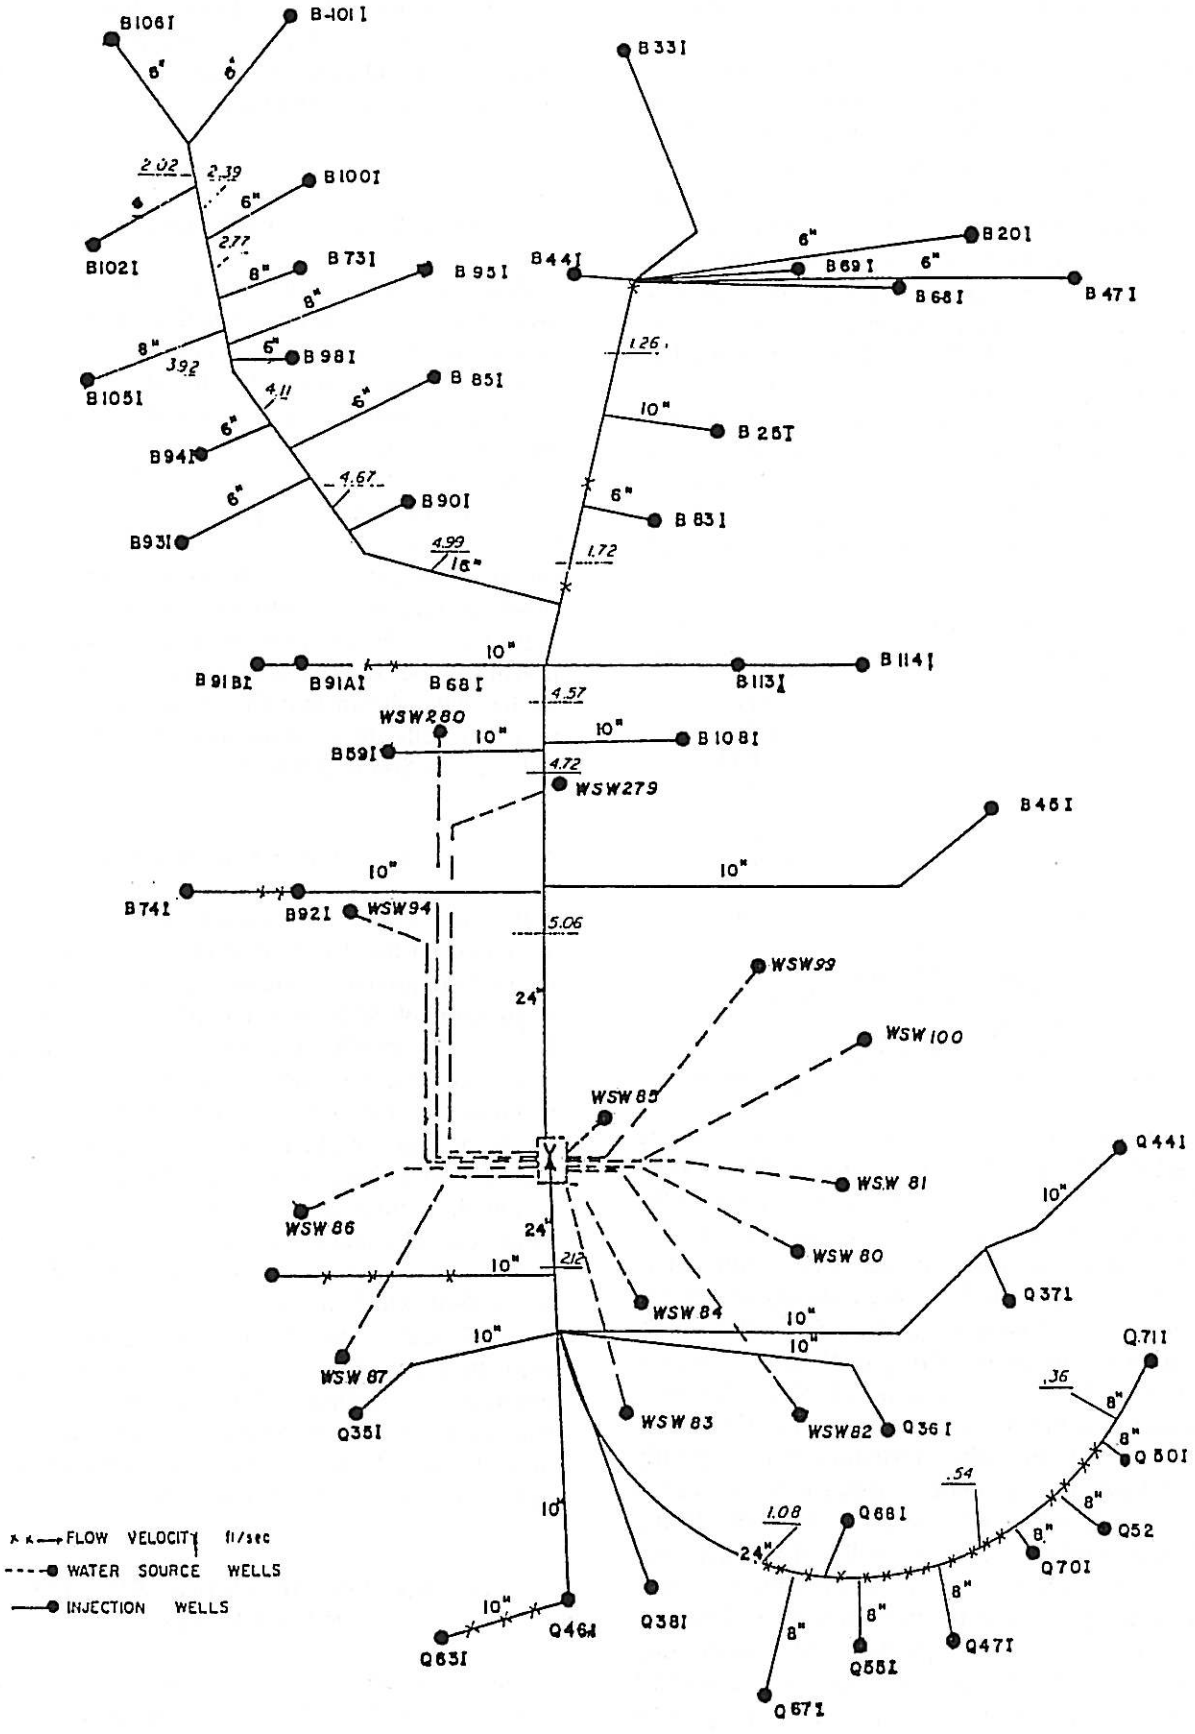
FIG. 1. DEFA water flood system.

The DEFA waterflood system (Fig. 1) was originally designed in the early 1970's with a capacity of 250,000 barrels of water per day. In the late 1970's, the system was expanded to an ultimate capacity of 500,000 bbls/day. In 1982, the booster station was expanded to provide the additional pressure required for water injection. However, with every attempt to increase the system pressure, numerous leaks occured on the trunk lines and distribution lines, particularly at the extremities where the velocity is less than 1 ft/sec (0.3048 m/sec). Most failures occur in the lower quadrant of the pipe with severe pitting corrosion under heavy iron sulfide scale build up. Waterflood production is divided on severe source wells (WSW) alternatively in operation. Water from source wells flows to pump station and via 24″ mainline and 16″ lateral to the injection wells. Filters are located at the wellhead and facilities for pigging the line are available. Because of present low production levels, only five water source wells are in operation producing a total of 225,000 bbls/day.

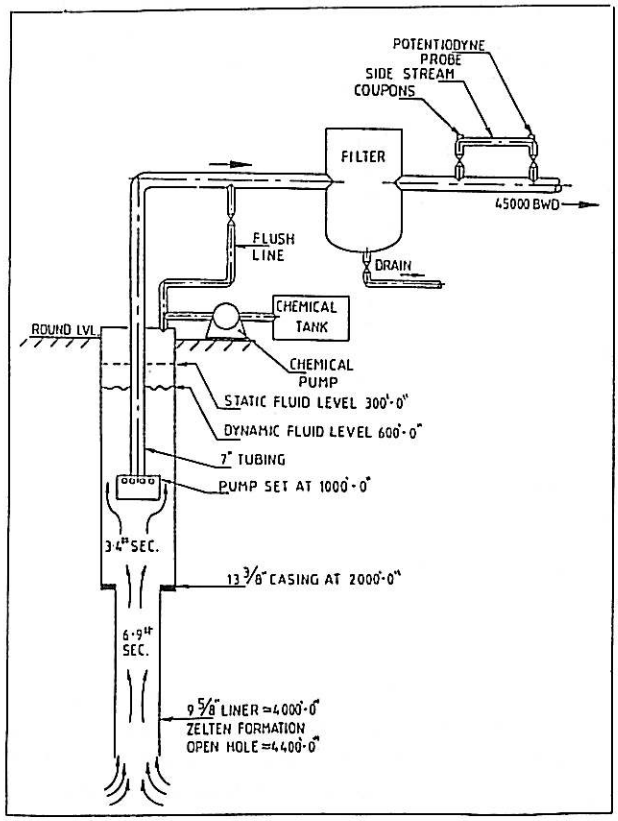
FIG. 2. Typical water source well.

The electrodes are equilibrated in the injection water under prevailing well head conditions as shown in Fig. 2. The scanning rate is kept at 4V/hr for all the runs on WSW 85. The procedure is typical of utilizing side-stream for inhibitor injection at different concentrations until practical predetermined level of corrosion rate is achieved. Each inhibitor is evaluated at three different concentrations 2, 4 and 6 ppm, and the corrosion rate at each concentration is measured at 0, 1, 3, 6 and 24 hours. However, due to iron sulfide deposition, the data at 24 hrs is not included in the evaluation. To prove it is the iron sulfide and not the filming ability of corrosion inhibitor, the corrosion rate without

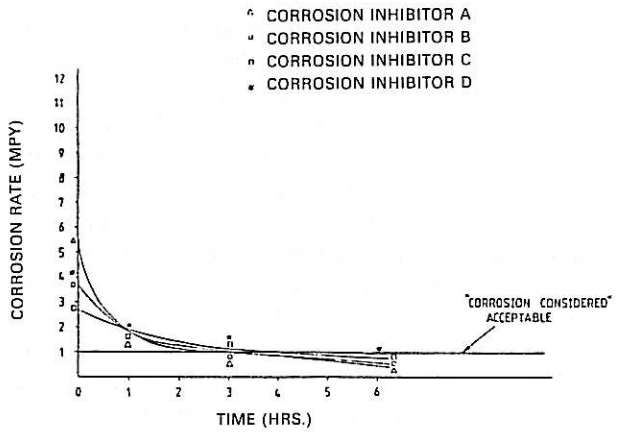
FIG. 3. Corrosion rate at 6 PPM.

In comparison with the presumed practical and economical corrosion rate of 1 mpy, the result shows that corrosion inhibitors A, B, C and D are all effective at 6 ppm as shown in Fig. 3. However, this concentration is measured at the well head, and as we move farther from the injection point, this concentration diminishes due to filming properties of these inhibitors. Therefore, inhibitor B is not recommended for use at concentration below 4 ppm level as shown in Fig. 4. All chemicals are ineffective at 2 ppm as shown in Fig. 5.
