PRJ, Vol. 3 (January 1991); P. 57–62, 9 FIGS, 1 TABLE.

SENSITIVITY OF PIPE-LINE STEELS TO HYDROGEN INDUCED CRACKING

Adam Mazur*, Tarek Militti* and Khalifa Abosowa*

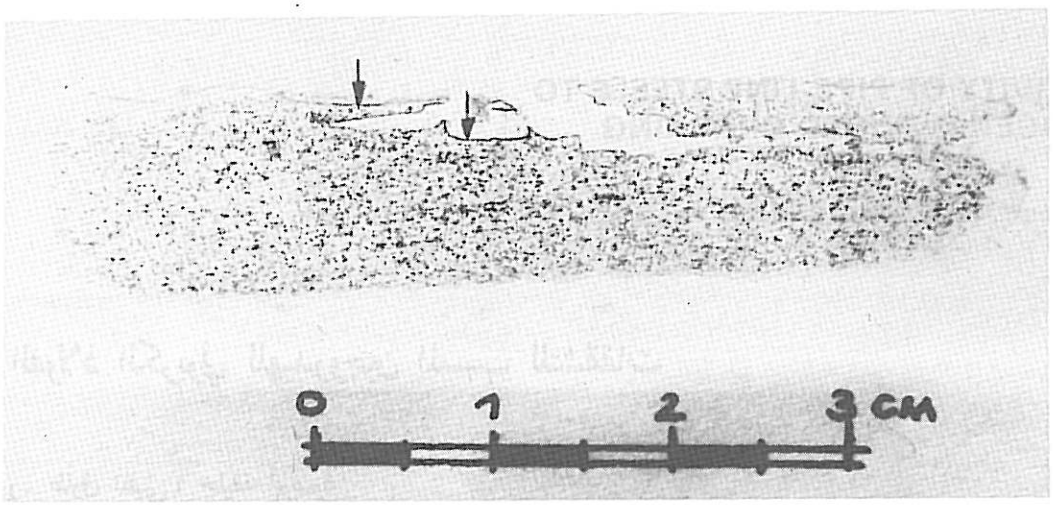
FIG. 1. Sulphur print made from the specimen of steel (P).

From each pipe the longitudinal specimens were taken for macro- and micro-observations. All specimens of pipe (P) exhibited many open blisters and inner cracks of lamination type; some of them formed the step wise cracks. Macro-sulphur print in Fig. 1 shows the cracks in the pipe-wall opened in the inner pipe surface. Figure 2 shows sulphur print with stepwise crack situated close to the inner pipe surface. The dark spots indicate the places occupied by non-metallic inclusions (Mn, Fe)S as impurities inherited after metallurgical processing. Black de-posit (FeS) along the cracks (See arrows in Fig. 1 and Fig. 2) are the product of reaction between wet H_2S environment and inner pipe surface. Cathodic reaction is hydrogen ion reduction as illustrated below:

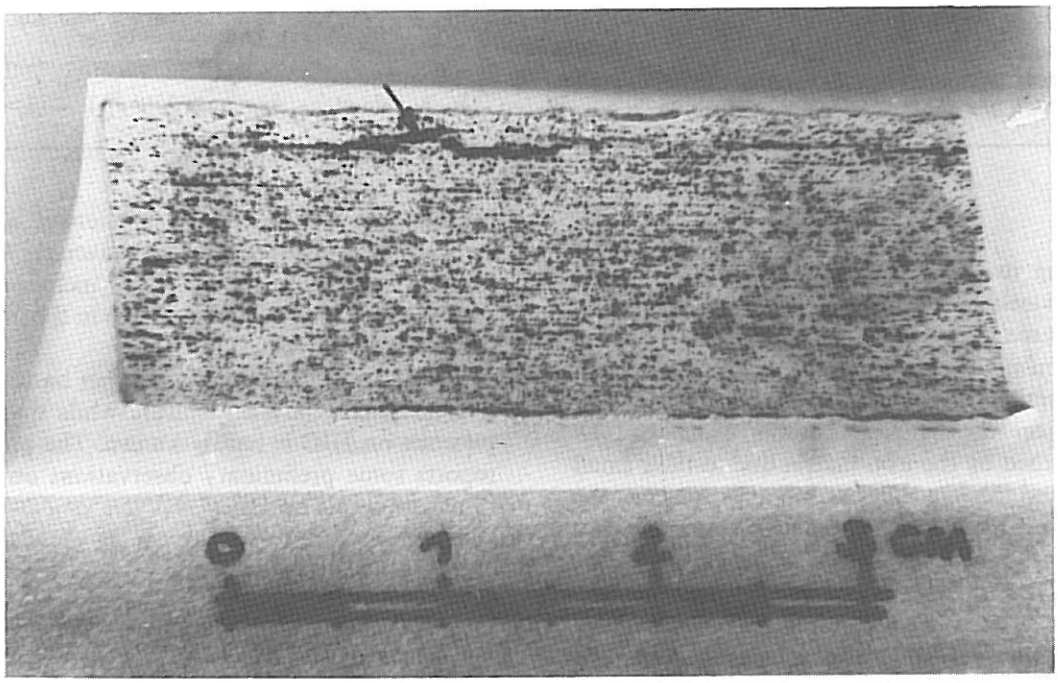
FIG. 2. Sulphur print of Steel (P) with stepwise crack. Dark deposit marked by arrow indicates that the crack had a direct contact with H_2S.

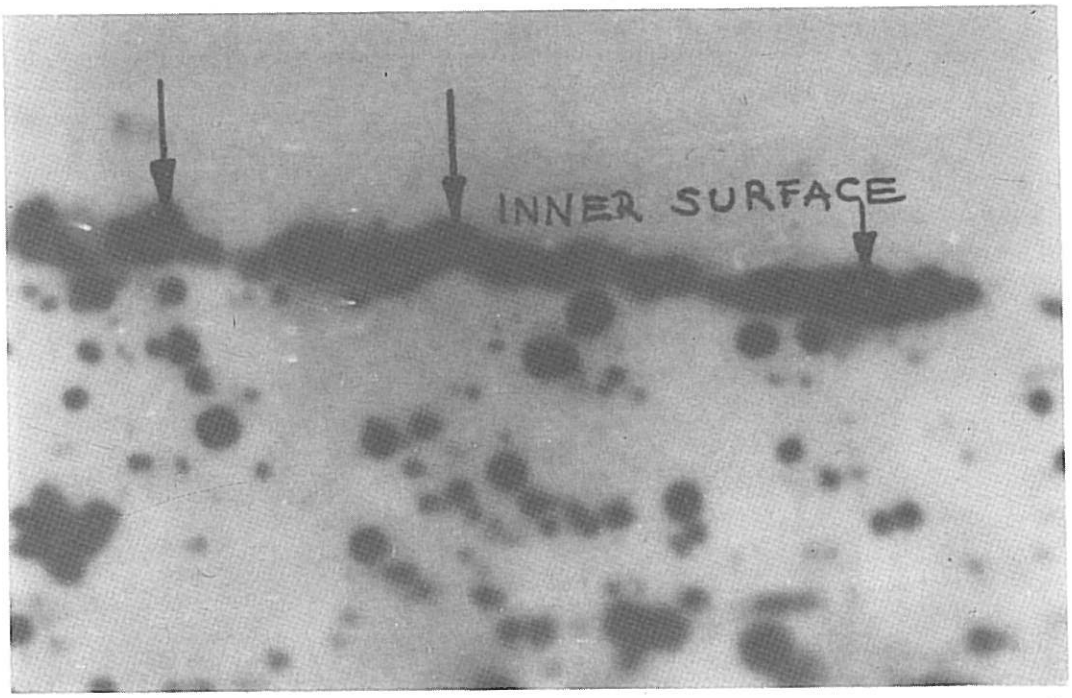
FIG. 3. FeS deposited at the pipe inner surface due to the reaction between H_2S and Fe. Sulphur print magnified 63×.

Part of the hydrogen atoms is absorbed by steel and can diffuse into the iron matrix producing hydrogen induced cracks (Blisters or stepwise cracks), the rest of the atoms recombine into molecules and flow away with the gas stream. This deposit, along the inner surface of the pipe, is shown after magnification in Fig. 3. Samples taken from pipe (E) did not exhibit hydrogen induced cracks in spite of the highest H_2S content in the gas.

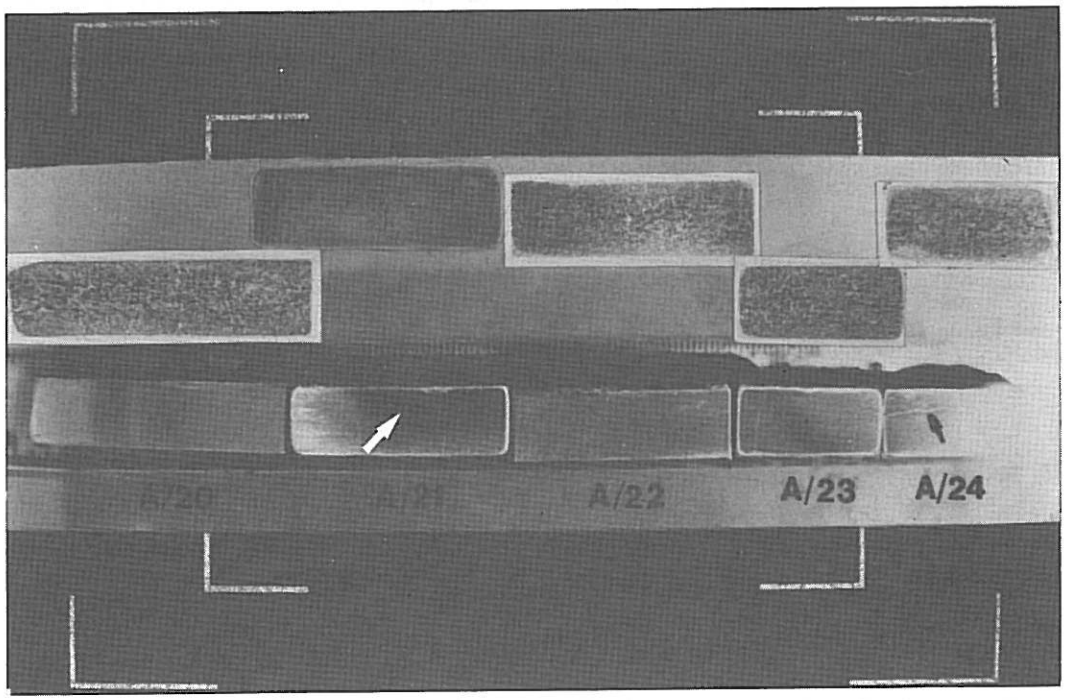
Macrophotographs and macro-sulphur prints of samples taken from the pipe (D) are shown in Fig. 4. They are visible in cross-sections with stepwise cracks (see arrows) without black deposit that indicates no direct contact of the cracks with the pipe inner surface.

FIG. 4. Samples of A series cut from pipe of (D) type. The arrows are showing stepwise cracks in the section A/21 and A/24. Sulphur prints are showing the (Fe, Mn) S distribution in the cross-section.

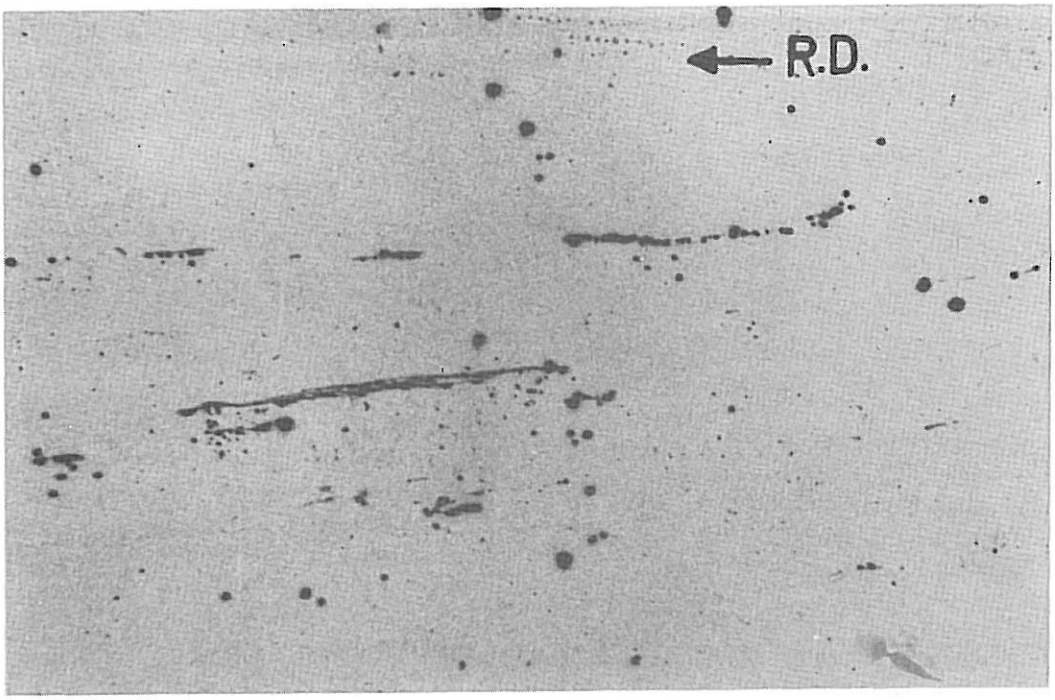
FIG. 5. Elongated non-metallic inclusions due to high deformation stage due to hot rolling. Magnification 130×.

The steels used for pipe production have been hot rolled. This operation produced high directionality of structural constituents and non-metallic inclusions. Fig. 5 shows the nonmetallic inclusions elongated towards rolling direction (RD). Similarly, the segregation areas are elongated and form the bands shown for steel (E) in Fig. 6.

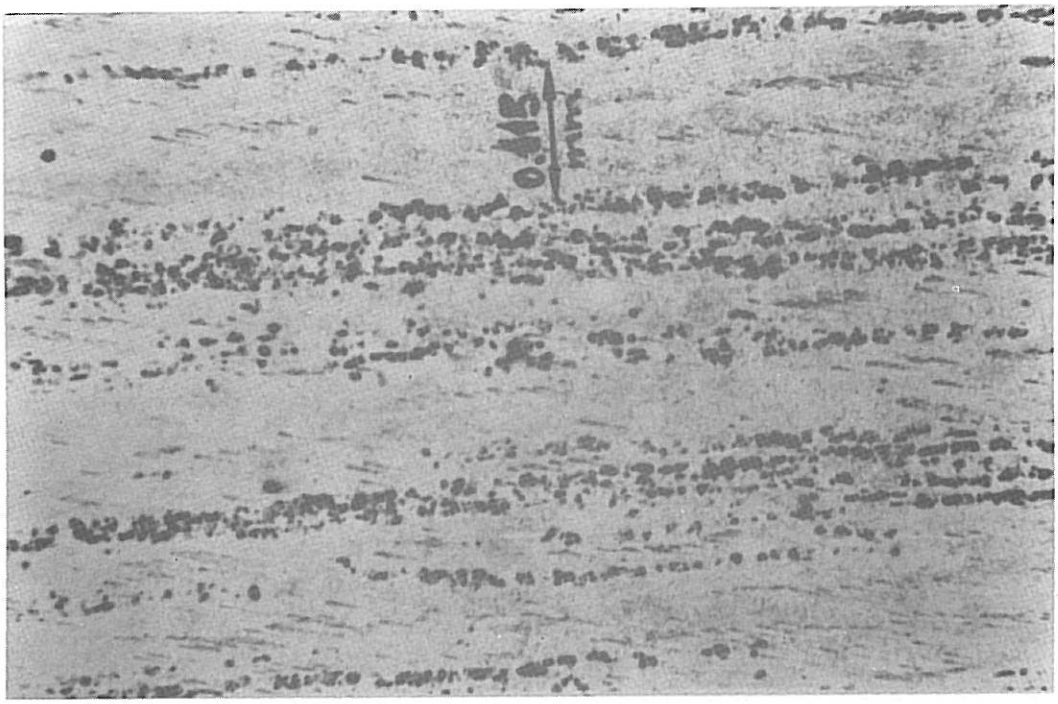
FIG. 7. Phosphorous bands of 0.115 mm of average width (light colour) in steel (P) Stead's reagent. Magnification 130×.

(light colour) and the depleted one (dark colour) for this steel is 0.03 mm. This steel was not sensitive to HIC. Fig. 7 shows for comparison the 0.115 mm wide enriched phosphorous bands in steel (P) that exhibited a great deal of HIC.

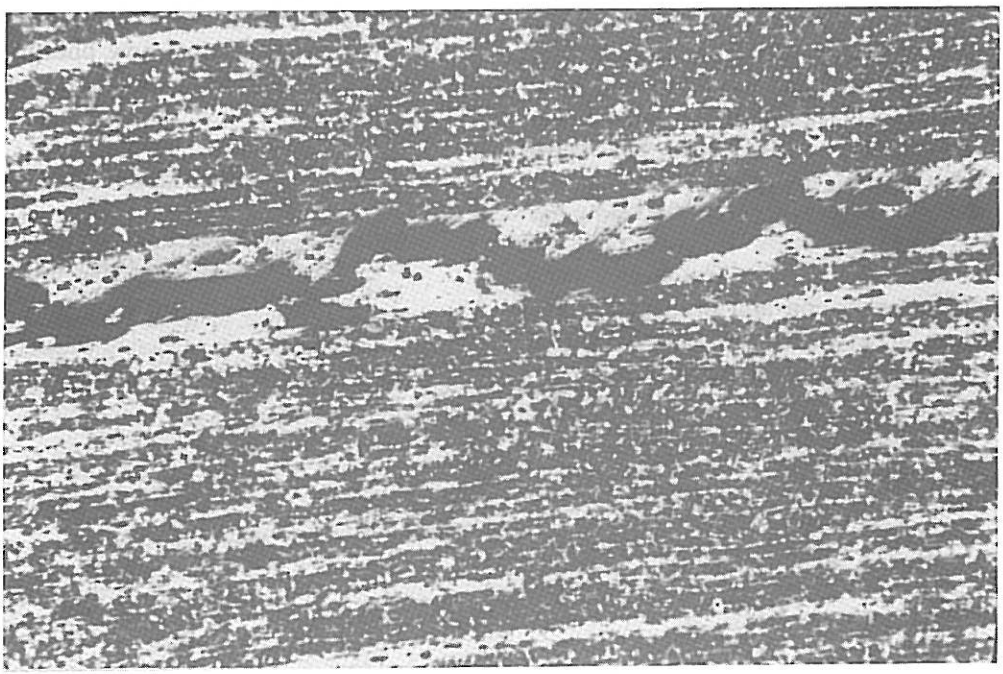
The stepwise cracks propagated usually along a wide 0.2 mm band enriched by phosphorous white (or light) bands (see Fig. 8). In the 0.25 mm wide band the stepwise cracks are propagating following the "rolling direction". Fig. 9 shows the two stepwise cracks following wide phosphorous band approaching the area in which 0.3 mm wide segregation bands became narrow and unfavourable for further crack propagation (see arrows). Extremly high forces developed at both crack tips produced deformation of the metallic fibers between these cracks. The above examples illustrate the fact that at the microscale in steel (D) the phosphorous segregation has changed from very

FIG. 8. Stepwise cracks in the 0.25 mm wide phosphorous band. Oberhoffer's reagent. Magnification 130×.

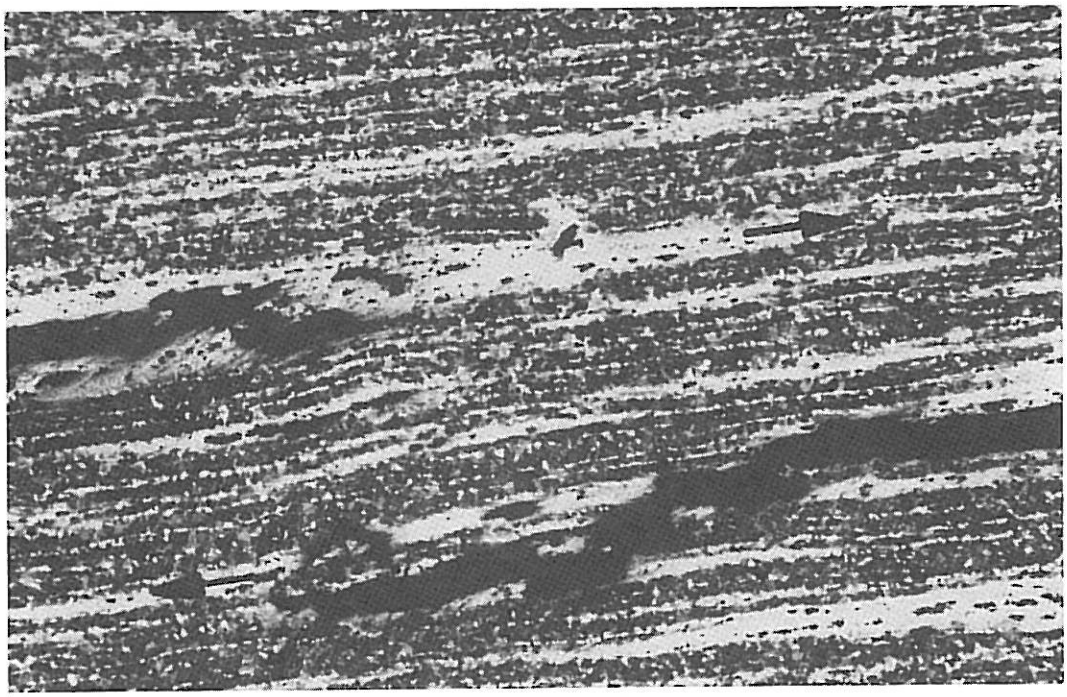
FIG. 9. The situation in the area where two stepwise cracks are arrested due to narrowing (see arrows) the phosphorous bands. Note a plastic deformation of the structure between both cracks ends. Oberhoffer's reagent. Magnification 63 ×.

wide enriched in phosphorous bands, in which many of stepwise cracks have been originated, to very narrow one in which stepwise cracks could not propagate. Probably, the high phosphorous content in this steel exceeded 0.05%, and the uncontrolled solidification process caused such complicated mode of phosphorous segregation and high susceptibility to stepwise cracking of the steel (D). All samples exhibited phosphorous bands wider than 0.1 mm. The steel (P) should be placed in the area of bands over 0.1 mm (measured average band was 0.115 mm). Steel (E) in which stepwise cracks have not been found exhibited bandwidth of about 0.03 mm. The rough estimation of the critical phosphorous segregation bandwidth gave the values between 0.03 mm and 0.1 mm. If the bands are below 0.03 mm the steel should not be sensitive to HIC. The steel is very sensitive to cracks nucleation and propagation due to the presence of H_2S in the natural gas if the phosphorous bands are wider than 0.1 mm.
