PRJ, Vol. 3 (January 1991); P. 63–67, 13 FIGS, 2 TABLES.

THE ATMOSPHERIC CORROSION OF AUSTENITIC STAINLESS STEEL PNEUMATIC TUBING SYSTEM IN AN OFFSHORE ENVIRONMENT

M.L. Mehta* and K. Abosowa*

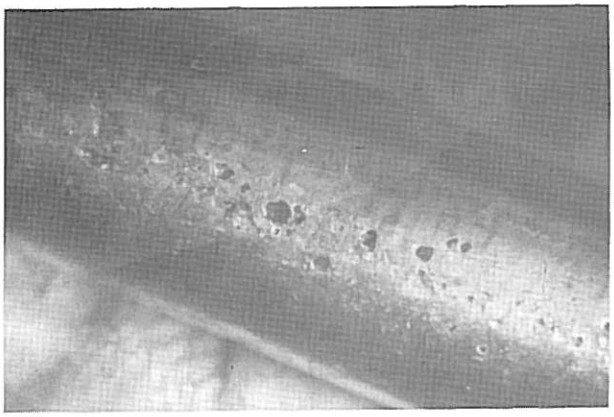
Localized attack did not take place over the whole tube surface but was confined to a narrow band in the longitudinal direction as illustrated in Figs. 1, 2. Such morphology results from crevice corrosion. Scattered pits as in Fig. 3 were also seen. Figure 4 shows a ring around a cluster of pits indicating the existence of a deposit over these pit sites, which had come off. Figure 4a reveals the growth of adjacent

FIG. 1. A band of pits resulting from crevice corrosion × 6.

Localisation of crevice attack to one side of the tubes suggests that the tubes remained in contact with other tubes/holding channels. This contact areas remain shielded from the supply of oxygen creating differential aeration corrosion cells. Salt deposited on the tube surface from marine atmosphere accelerates corrosion activity in corrosion cell [1], causing local break-down of passive film leading to crevice and pitting corrosion.

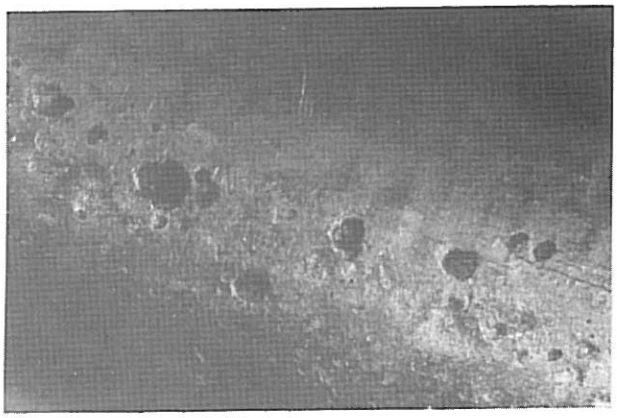
FIG. 2. Another area showing crevice corrosion × 12.

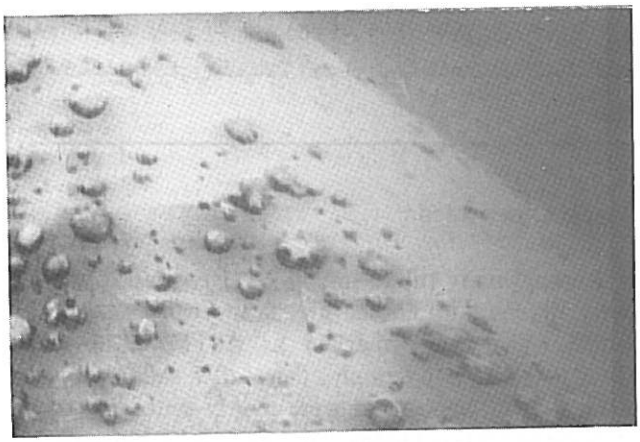
FIG. 3. Scattered pits and particles deposited on tube surface × 64.

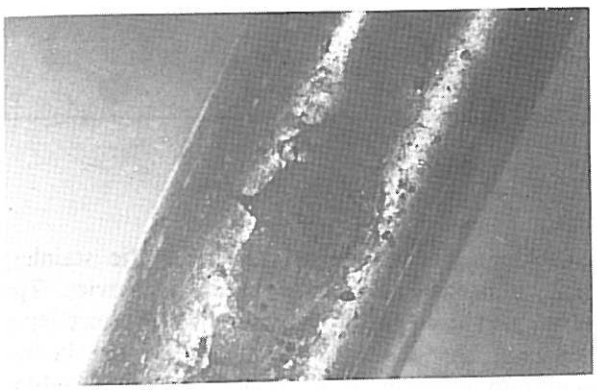
FIG. 4. A ring around a cluster of pits × 6.

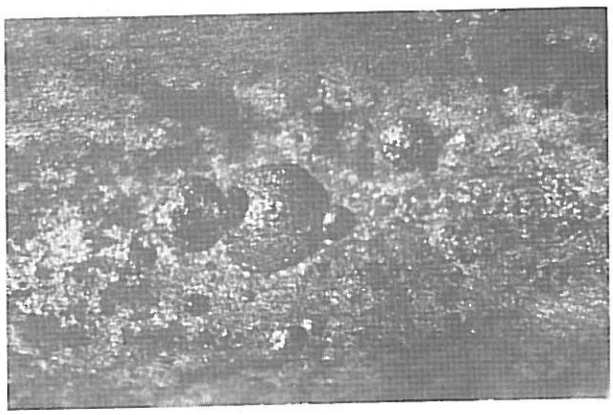
FIG. 4a. Growth of adjacent pits leading to a large pit × 12.

pits till they emerged into one another leading to large pits. Figure 5 illustrates pits under the particle deposits on the tube surface.

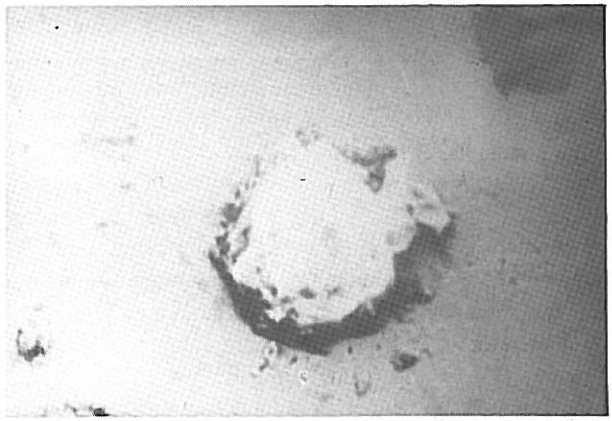
FIG. 5. A pit under the particle deposit × 124.

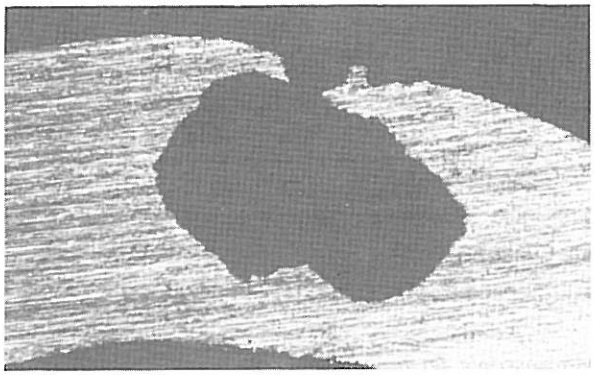
This was carried out in the transverse section of the pitted region of the tube. Figure 6 shows the undercut appearance of a pit indicating typical chloride attack. The pit has penetrated about 4/5 of the wall thickness. Figure 7 illustrates another morphology (open pit). Figure 8 shows a pit in the cross-section of the tube which penetrated at an angle to the tube surface. Microstructure was examined in the transverse section of the tube. Figure 9 shows that the tube was not seamless, but it was fabricated through fusion welding and the structure of weld was

FIG. 6. Under-cut pit typical of chloride attack × 65.

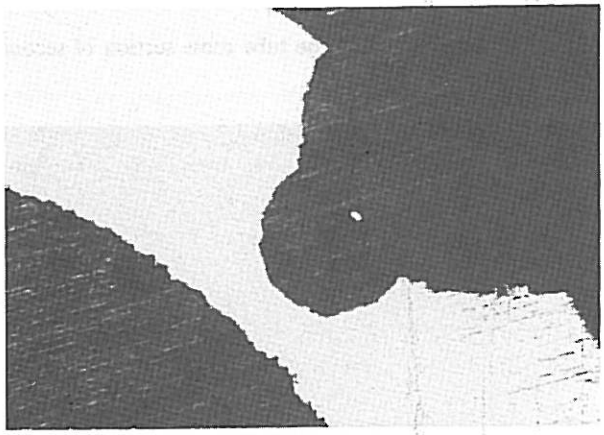
FIG. 7. An open pit × 65.

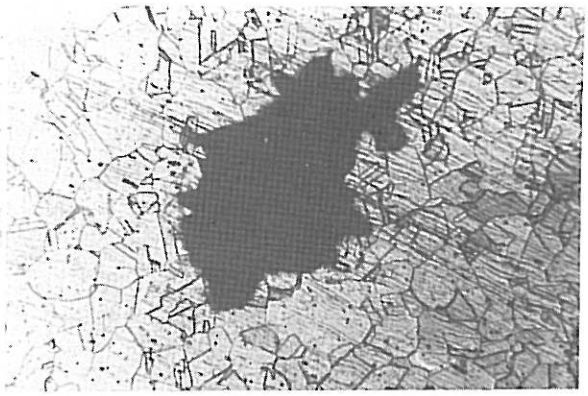
FIG. 8. A pit in the tube cross section × 260.

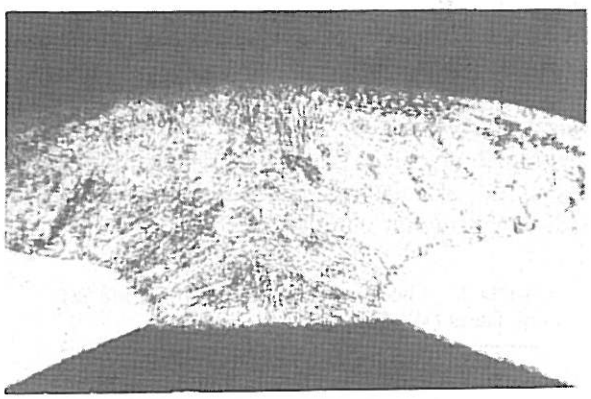
FIG. 9. Fusion weld having dendrite structure × 65.

dendritic. The structure of the base metal as seen in Fig. 10 consists of equiaxed grains, annealing twins, second phase particles and tube has been subjected to slight cold deformation as evident from the presence of deformation markings due to slip.

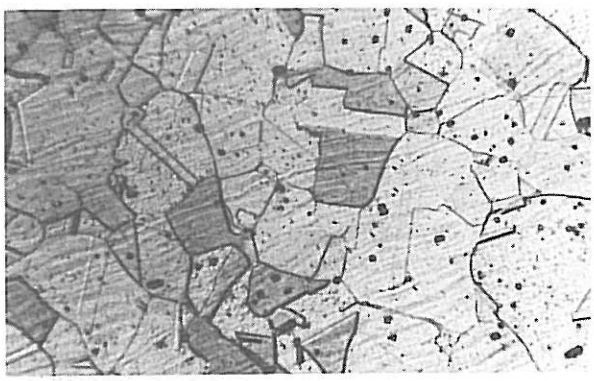
FIG. 10. Microstructure showing grain structure, annealing twins, second phase precipitates and deformation markings × 520.

The difference in behaviour of the two sets of tubes may be due to surface treatment given to the second set of tubing imparting more resistance to pitting corrosion. Further, presence of higher amount of second phase particles as seen in the micro-structure of first set of tubing increases pit initiation [2].

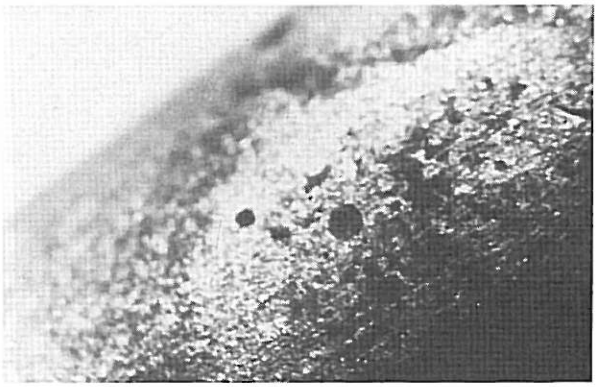
a.

Mild pitting was observed on tubing surface as illustrated in Fig. (11a,b) and had random distribution.

FIG. 11a,b. Show pits in the tube surface of second set of tubes × 6.

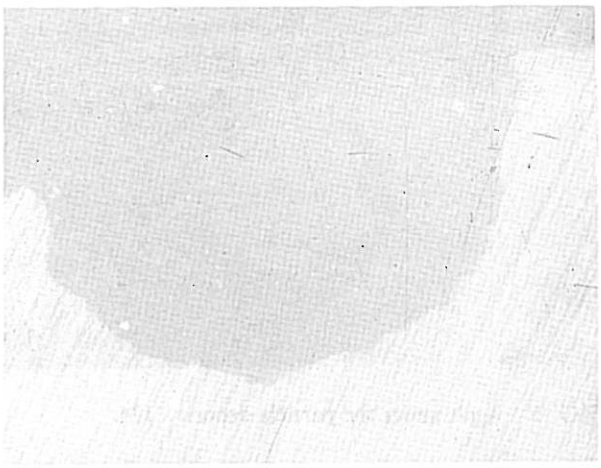
Many cross-sections were examined and only a few shallow pits were seen. Figure 12 shows the undercut pit which penetrated only 1/20 of the wall thickness. Unlike first set of tubing second set of tubing was seamless.

FIG. 12. Shallow pit in the tube cross section of second set of tubes × 130.

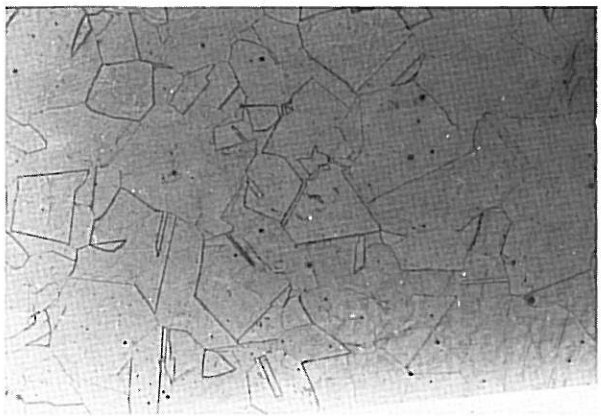
Microstructure consists of equiaxad grain structure showing twining and presence of second phase particles as seen in Fig. 13; quantity being much less than that detected in the first set of tubes.

FIG. 13. Microstructure showing less quantity of second phase precipitates × 400.
