PRJ, Vol. 2, (January 1990); P. 63–66, 5 FIGS, 1 TABLE.

H_2S INDUCED LOCALIZED CORROSION OF AUSTENITIC STAINLESS STEEL BELLOW: A CASE STUDY

M.L. Mehta* and A.T. Hassan*

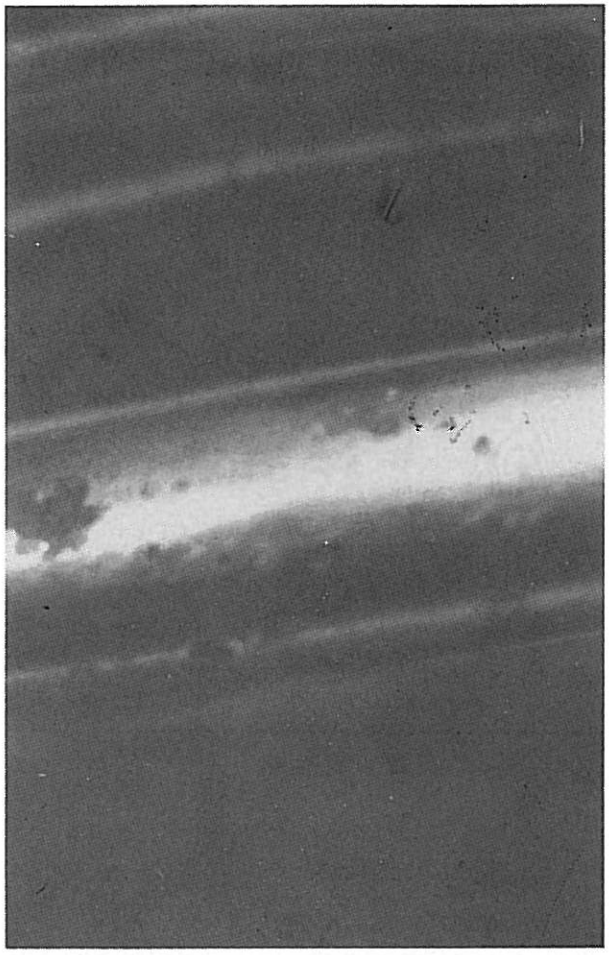
Extensive pitting were observed both on internal and external surfaces of the bellow. Some of the pits have propagated through wall thickness (0.3 mm) of the bellow. Fig. 2 shows pitting on the external surface of the bellow in their different stages of developments. Some pits had initiated revealing that pitting can start from outer surface and environment surrounding the external surface of the bellow is also corrosive enough to cause pit initiation and their propagation. Deposit

FIG. 2. Pitting on external surface of the bellow showing different stages of their growth X6.

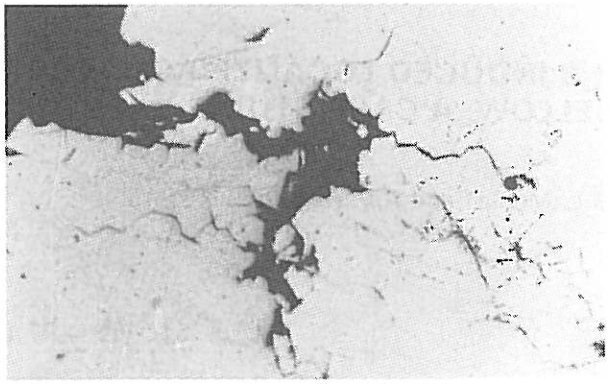
Samples having different degrees of pitting were cut from bellow. Morphology of localized corrosion in the form of intercrystalline cracking, intercrystalline corrosion as well as pitting corrosion were detected as seen in Fig. 3. Figs. (4a, 4b) show early stages of localized attack which started from grain boundaries and progressed into grains to form pits.

FIG. 3. Intercrystalline cracking and pitting (unetched) X500.

The observation that bellow has also suffered from intercrystalline cracking is difficult to explain as they could be caused by either corrosion fatigue or stress corrosion cracking. Since bellow is subject to pressure variation due to its nature of operation, corrosion fatigue appears to be more probable. It is also observed that initially intergranular attack occurs as illustrated in Fig. 4 and this spreads leading to formation of pits.

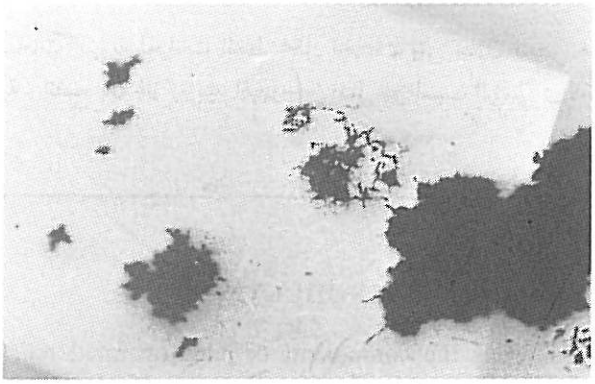
FIG. 4(a). Showing pits in their different stages X125.

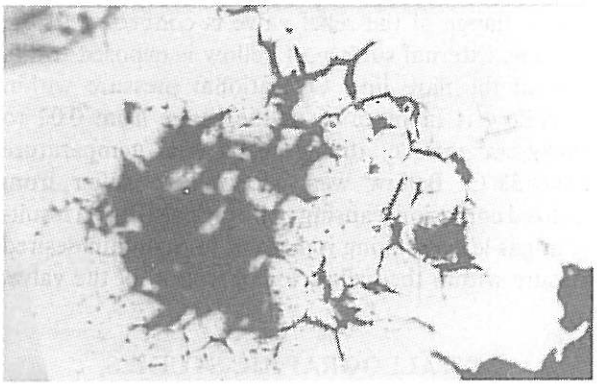
FIG. 4(b). Encircled area in Fig. 4a showing intergranular attack leading to formation of pits X500.
