PRJ Vol 1, (January 1989); P. 34–36, 5 FIGS.

FAILURE ANALYSIS OF A WIRE - LINE DUE TO CORROSION FATIGUE

A . Mazur * and F . El Shawish *

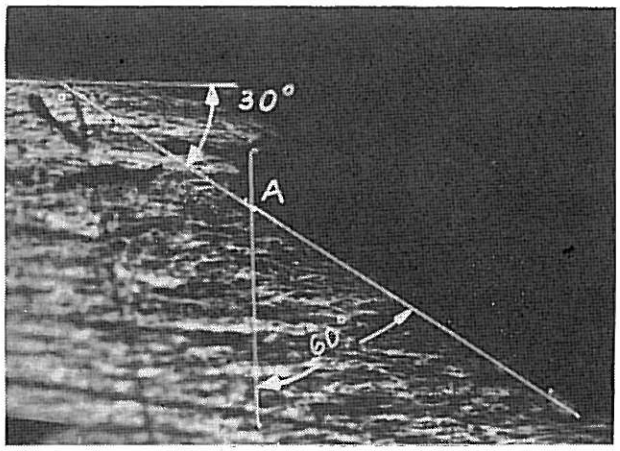
Few samples of 2.34 mm diameter steel wires were taken from a broken wire-line operated at a well of Agip Co. during a relatively very short time. Wire surface was smooth without the signs of general corrosion damage. The fractured surface from point A (Fig. 1) is inclined to the wire surface of about 30°.

FIG. 1. Longitudinal cross-section of the broken wire-line Nital etched, magnification 300X.

tion is typical for fracture of composite materials also. It is worth stressing that when the main crack changes the direction (about 60° inclination, see Fig.3) the process is similar to stress-corrosion cracking. It has been interpreted (4) that the stress distribution around the tip of a static crack is such that the maximum normal stress along the crack plane is significantly less than along planes inclined 60° to the crack tip. This was said to encourage development of "advance" cracks away from the plane of the main crack. Therefore, the final fracture is inclined about 60° to the transversal main crack initiated at the wire surface. Such final situation is shown in Fig.1.

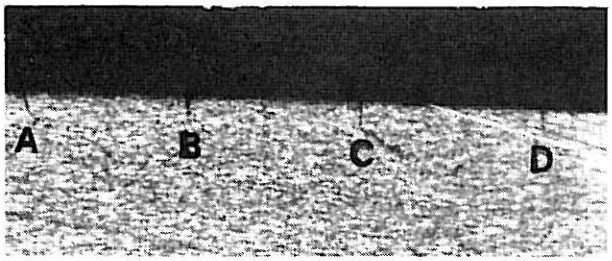
The longitudinal cross-sections were prepared from the wire-line that failed during operation. Fig. 2 shows four short transverse cracks (marked A,B,C and D). Generally, the cracks started at a tiny surface defect similar to the corrosion pit shown by the arrow in Fig.3. After some distance (marked by A-B) the main crack changed direction along the path inclined of about 60°. Along this inclined path the crack produced a zig-zag pattern. A high optical magnification revealed that the zig-zag crack consists of short transversal (T) and parallel sections (A-A) visible in Fig. 4. Usually the transversal parts (T) ended by producing two arms (A-A).

FIG. 2. Surface cracks marked by A, B, C, and D Longitudinal cross-section. Nital etched, magnification 60X.

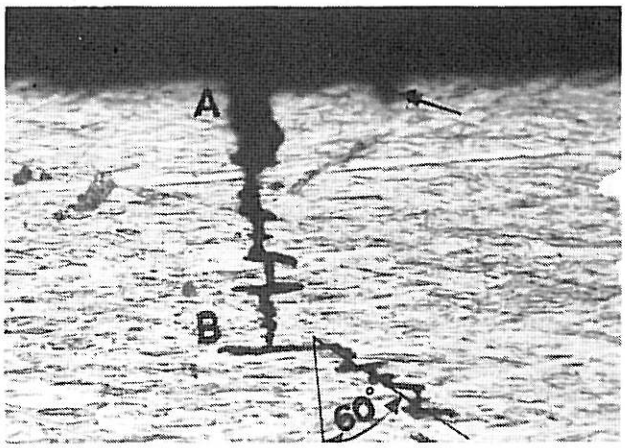
FIG. 3. Main corrosion fatigue crack started at point A. The zig-zag crack path started at point B. An arrow shows small corrosion pit as a site of corrosion fatigue crack initiation. Nital-etched, magnification 600X.

The corrosion also played some role in widening (dissolution effect) the upper part of a transversal crack as is cleary visible in Fig. 3. Therefore the parallel situated fibres could not effectively arrest a main crack.

physically, K_I represents the plastic zone at the crack tip(A).
If the value of K_I is higher the plastic zone is more developed and materials resistance against brittle fracture also increases . Therefore at some distance the main crack becomes effectively arrested (See Fig.3 point B) developing two perpendicular arms until fatigue-corrosion process reaches a weak structural point where the next transversal crack can break a few metallic fibers. Then again, the crack is arrested and the process is repeated (see sequences T-A, T-A etc in Fig.4). Such zig-zag crack propaga-

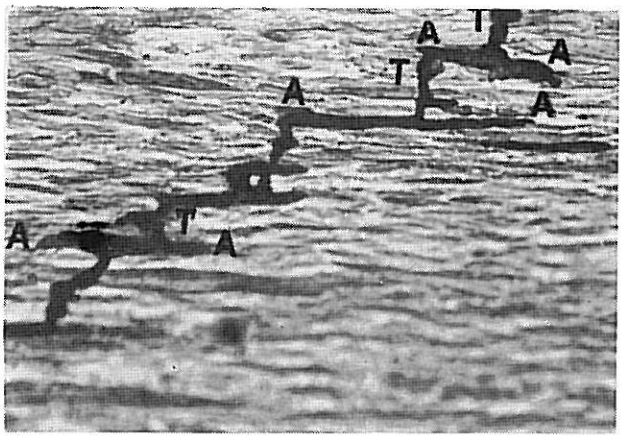
FIG. 4. Zig-zag crack pattern. Transversal part (T), parallel part (A-A). Nital etched, magnification 1200X.

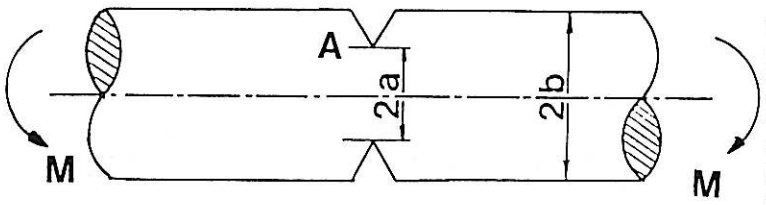
According to fracture mechanics principles (3), in the situation shown schematically in Fig. 5, if the crack is longer (a / b ratio smaller) the stress-intensity factor K_I increases due to change in geometrical functions F_{1-3} (a/b) as indicated by the following equation :

FIG. 5. Bending momentum acting in the wire with two surface cracks.
